TESTING OF TYPICAL SPACECRAFT MATERIALS IN A SIMULATED SUBSTORM ENVIRONMENT

by N. John Stevens, Frank D. Berkopec, John V. Staskus,
Richard A. Blech; and Steven J. Narciso
Lewis Research Center
Cleveland, Ohio 44135

TECHNICAL PAPER presented at the
Spacecraft Charging Technology Conference cosponsored by the
United States Air Force and National Aeronautics and Space Administration
Colorado Springs, Colorado, October 27-29, 1976

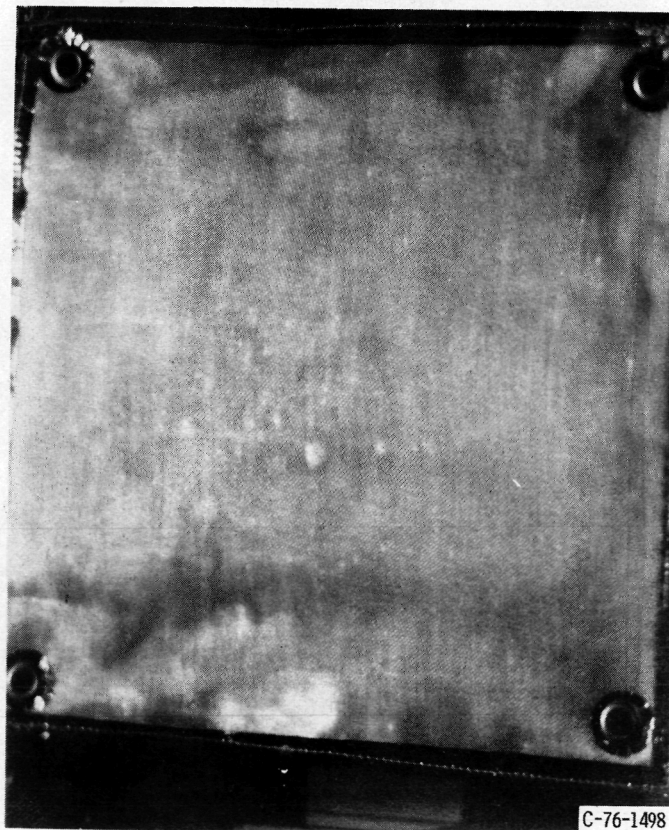
C-76-1498

Figure 14. - Glow on quartz cloth thermal blanket.

There were no discharges observed during these tests. However, as with the S-13G paint sample, the blanket did electrofluoresce in the beam. A picture of the sample glowing is shown in figure 14.
